**JET**
FILTER**Maintainable Weep Hole System**

Relieving Water Pressure with Weep Hole Filters

Location: Lake Park Marina, Lake Park, Florida

The Situation: Failing Sidewalks & Dangerous Potholes Lead to Concrete Seawall Repair

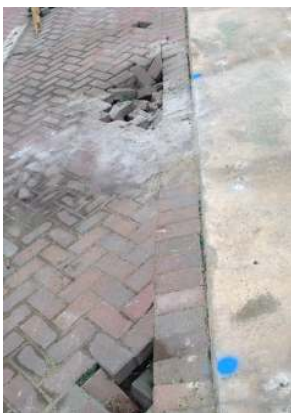
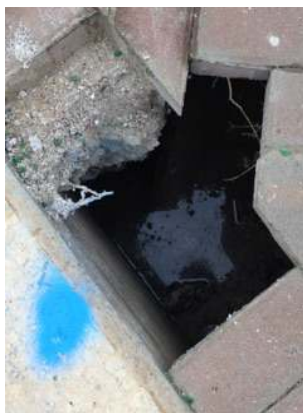
Teams thoroughly inspected the nearly 1600 feet of wall by probing the soils on the landward side of the wall as well as inspecting the panel/pile attachments on the water side. After removing some of the paver sidewalk, very weak soils and voided areas were found on the landward side. Additionally, many seawall panels were found to be off-set and not properly attached to the pilings. A lack of proper drainage from rainfall, storm events and runoff from the surrounding pavement caused the erosion.

When it rains in this area, the water has nowhere to properly drain with the exception of penetrating the brick paver areas around the marina. The water build-up behind the seawall panels will look for an exit through a weak panel/pile attachment joint, or worst yet, under the driven panels themselves.

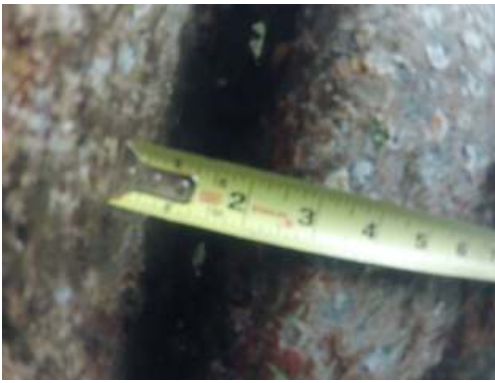
In this case, hydrostatic water pressure moved the panels to allow the water a path to the sea all the while taking the supporting soils with it.

Hydrostatic pressure develops when groundwater “stacks up” behind the seawall. This groundwater is trying to seek a level with the existing water table and will do so taking the path of least resistance. If it wasn’t for the panel joint issues, it may go under the driven panel (creating even more problems) or if the hydrostatic pressure becomes great enough, could crack the concrete panel horizontally to create its own leak.

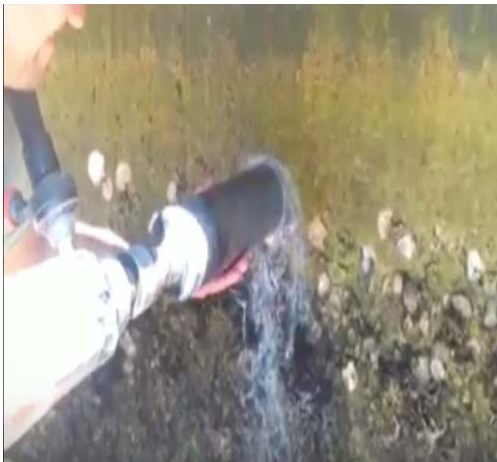
The only way to properly address the issue is to vent the wall right above the normal barnacle line to give the water a defined, easier path to drain and to seal the panel joint failures! Mounting the filters in this area of the panel totally eliminates future hydrostatic pressure, and creates the new, *easiest* path of least resistance for water exfiltration.

In November 2014, Jet Filter System and Alon Beilis from Sea Me Dive were brought in to assess and fix the drainage issue. They installed 147 stainless steel, 4” weep hole filters manufactured by Jet Filter Systems of Casey, IL. Four-inch core holes were drilled through the center of the 10’ panels. If any steel rebar was exposed during drilling, it was treated with an epoxy sealant prior to filter installation.
