Relieving Water Pressure with Maintainable Weep Hole Filters

Location: Wrightsville Beach Marina, Wrightsville, North Carolina

The Situation: Seawalls & Bulkheads Bulging After Storm Event

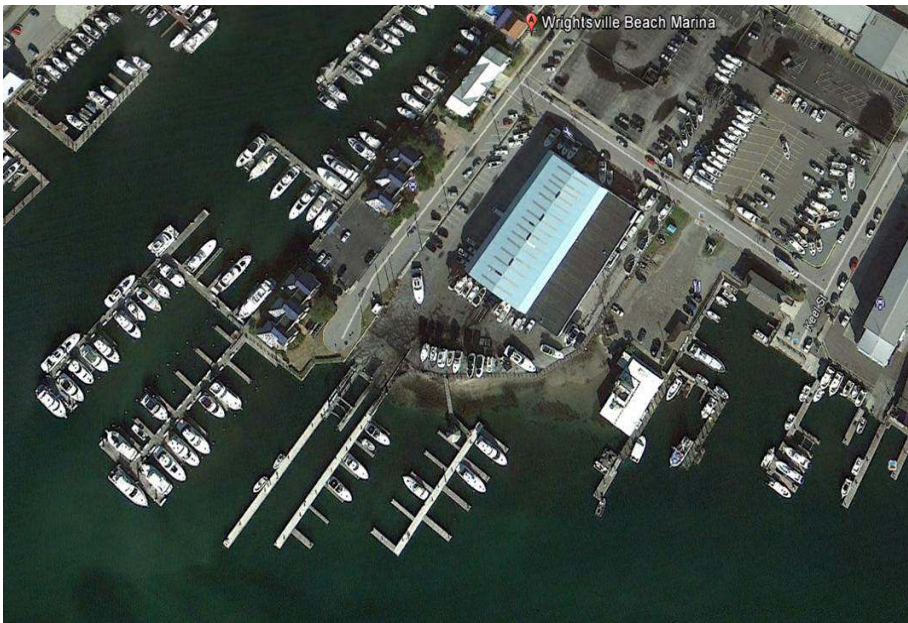
During a routine inspection after a storm, the Wrightsville Beach Marina team noticed bulging in their steel sheet pile seawall. Bulging in a seawall or bulkhead can occur when water pressure builds up against the soil side of the seawall or bulkhead. Without drainage, the wall can bulge, bow and tilt. If not repaired, the seawall will ultimately fail.

After inspecting the affected areas, Intercoastal Contracting determined that the panel bulging was indeed created by extreme hydrostatic pressures that developed on the landward side of the wall during a recent heavy rain/storm event. Water can more than double the weight that the soil exerts on the wall. Left undrained, the water pressure will eventually push through the wall or under the wall. Either way, the water will erode soil as it escapes.

After reviewing the situation, Jet Filter System recommended installation of their 4" stainless steel **Maintainable Weep Hole Drains**. Unlike any other seawall drainage system, maintainable weep hole drains can be installed and serviced from the front of the wall. This feature makes them the most reliable and cost effective drainage solution on the market.

Jet Filter system recommended the units be installed 10' on center, just above the mean water line to allow proper drainage of the land born water while at the same time eliminating any soil loss.
