Failing Seawalls Relieve Hydrostatic Pressure with Weep Holes

by Sean Goforth

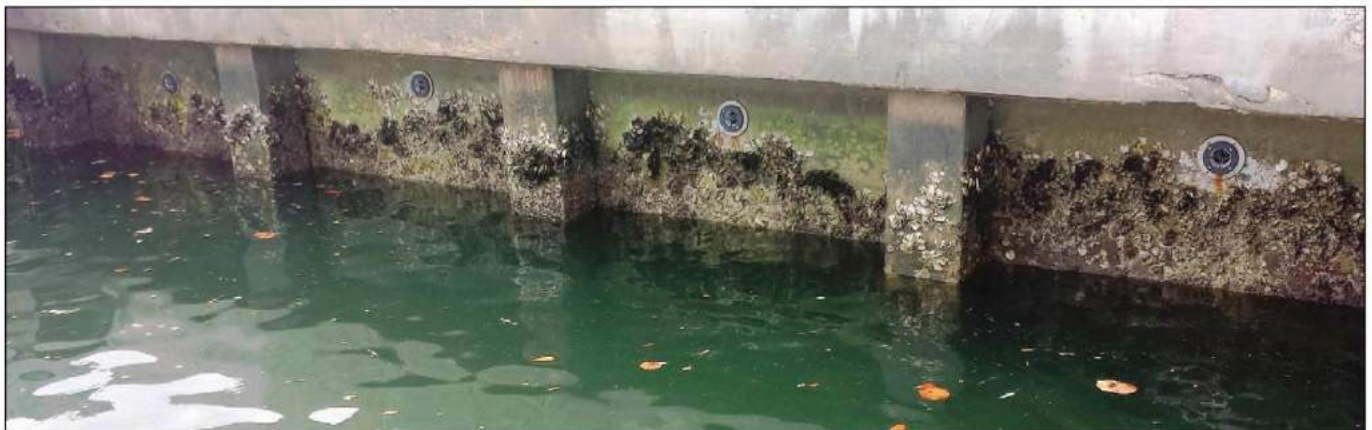
Lake Park Marina in Lake Park, Florida (not shown here), renovated its failing seawall with 150 weep holes from JET Filter. The weep holes relieve hydrostatic pressure behind the wall, providing a mechanism for water to drain through the seawall.

In November of 2014, Ft. Lauderdale-based Sea Me Dive started a seawall renovation at Lake Park Marina in Lake Park, Florida. The project included the installation of nearly 150 JET Filters. The installation process started with the Sea Me Dive team, led by Alon Beilis, setting up a floating work platform alongside a seawall panel.

The team then measured and marked off core drill points. Work platform spuds would be dropped into the seabed in order to allow for safe and stable core drilling. Once the site was prepared, the Sea Me Dive team would drill a hole through a concrete panel. The average concrete panel was 10 feet thick, and each hole took 15 to 20 minutes to drill.

On occasion, the core drilling cut through steel re-bar, in which case the interior of the hole would be sleeved with a PVC 4-inch pipe and cemented to the affected area with 5200 adhesive. After the drilling was complete, the Sea Me Dive team installed the Filter housing, comprised of 316 stainless steel pipe that was 4.25-inch thick and 2.5-inch long. Mushroom anchors were aligned and fitted into the pre-drilled holes, fixed the piping, effectively fastening the filter into the seawall. Sea Me Dive finished the project in April of 2015. A video of the installation can be viewed at: <https://www.youtube.com/watch?v=Ogaf771oPqY>
