Maintainable Weep Hole System

Geotextile Drainage & Erosion Control

Location: George Washington Memorial Parkway

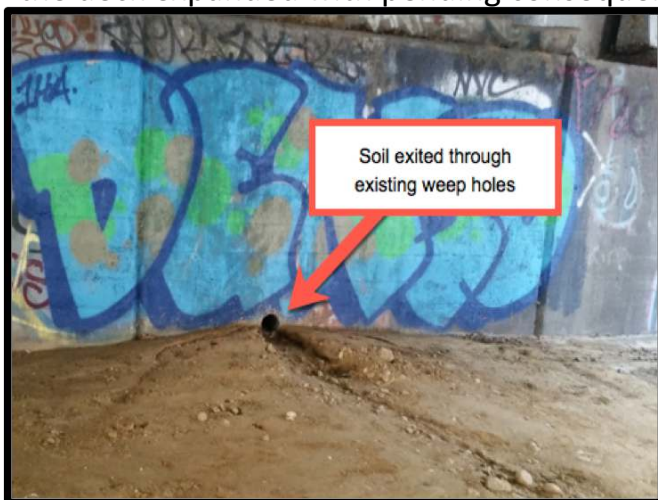
Situation: Built in 1930, the George Washington Memorial Parkway has stood the test of time shouldering commuter and tourist traffic along the shore of the Potomac River. Everything looked to be working well, but the bridge over Pimmit Run was hiding a potentially catastrophic secret. The erosion control system had failed and water was draining through filter fabric directly out weep holes in the bridge abutment below. Undetected, water was also eroding supporting deck soil. Over time, soil accumulated under the bridge while the voids under the deck expanded with pending consequences.

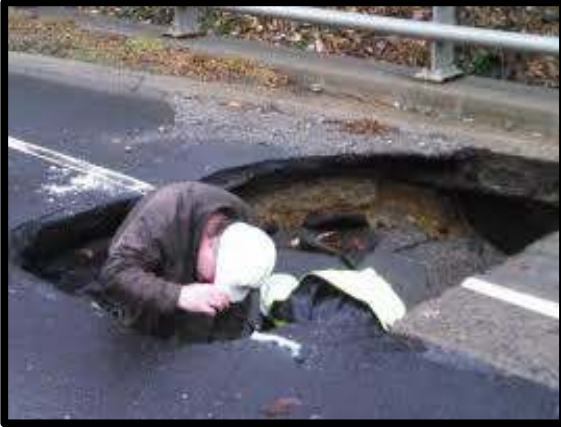
On December 1, 2014, the US Park Police were notified of a 4 car, pile-up on the Parkway. The deck had finally given way to a sinkhole 5' x 10' and 30' deep. Fortunately, no one was seriously injured.

Consideration Factors: Engineering and emergency repair crews were quickly on site to determine a plan of action. The erosion was more significant than the 5' x 10' opening, as voids now existed under all lanes of traffic. Repair of the decking was the easy part. Repairing the buried drainage system would not have been as simple.

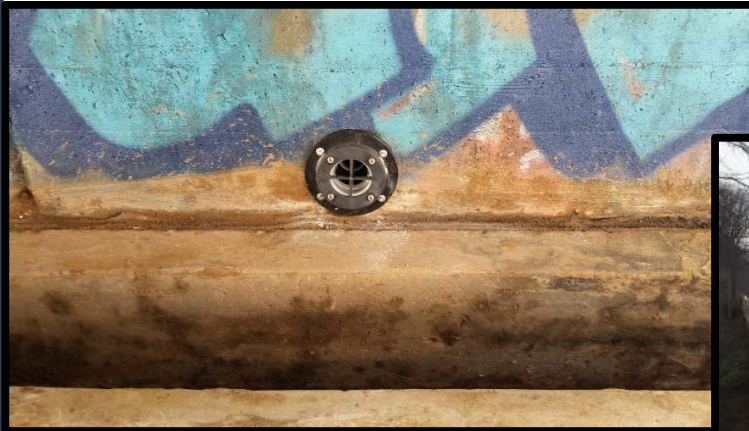
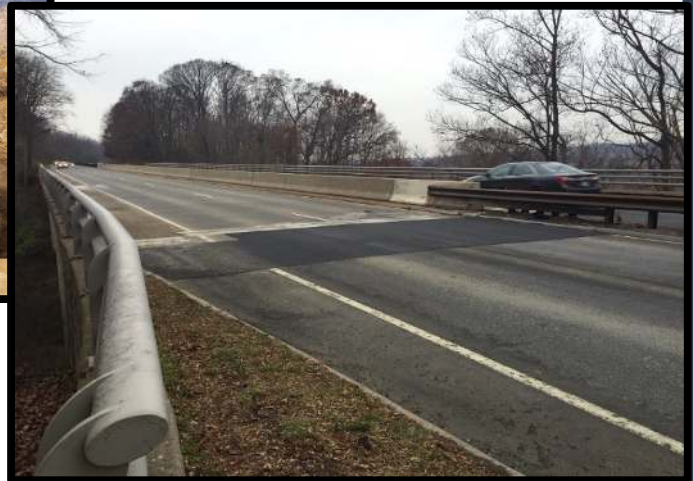
JET Filter System's 4" dia. maintainable weep hole filters were the right solution. Jet Filters were chosen over a new, behind the wall, drainage system that would have required extensive excavation to install. The Jet Filter contains a removable, cleanable geotextile cartridge for drainage & erosion control. This design allows installation & maintenance from the front of the wall. This approach decreases both installation & maintenance costs. The 4" dia. open-end Jet Filters were installed in each bridge abutment weep hole.
